RIVER BANK EROSION IN CENTRAL VIETNAM

TRAN TAN VAN

Vietnam Institute of Geosciences and Mineral Resources (VIGMR)

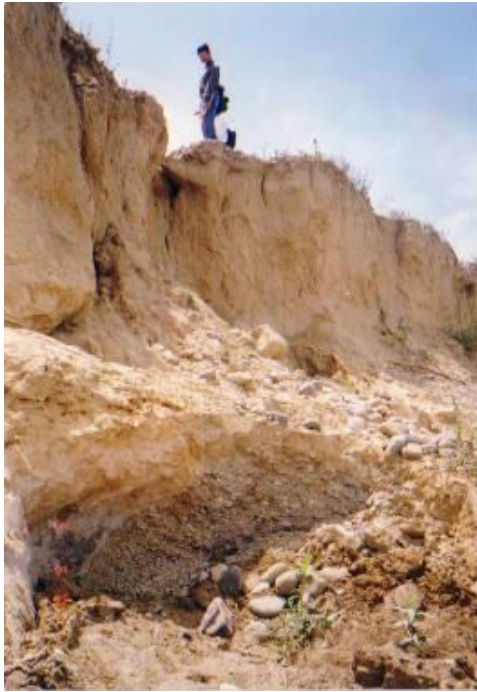
Our survey in 2001 indicated that after the 1999 historic flood, the right bank of the river was eroded severely with a section 450m in length, 0.5-3.5m in width and 5-5.3m in depth washed away. In total, within a period of 10-15 year, the bank retreated at some places up to 30m. According to our survey, soil subsidence and river bank erosion are closely associated. Underlying the Quaternary sediments of alluvial, alluvial-marine origins, consisting of loose sand, clay, grit and pebble, totaling 4-10m in thickness, is the dark grey, fractured and bedded, clayey and dolomitized limestone of either Cu Bai (D_{1-2} cb) or Cam Lo (P_2 cl) Formation, which cropped out only recently when the overburden sediments were washed away.

Figure 1 Bank erosion along the Hieu river.

Distributed along the Hieu River fault, coupled with water table fluctuation, the limestone is subject to karstification, forming underground cavities and resulting in the wide spread, though small but annoying, ground collapse. This accelerates river bank erosion and vice versa as local people rightly note that river bank erosion takes place even during the dry season, when the river water level drops down sometime rapidly and suddenly. Based on the

bank cross-section, the flow morphology and the current situation of erosion and subsidence, the problem was classified as moderate (Fig.1).

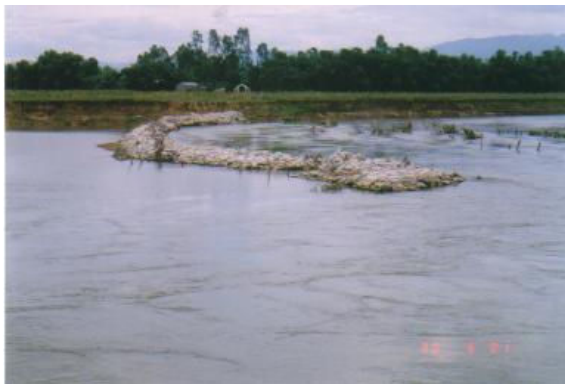
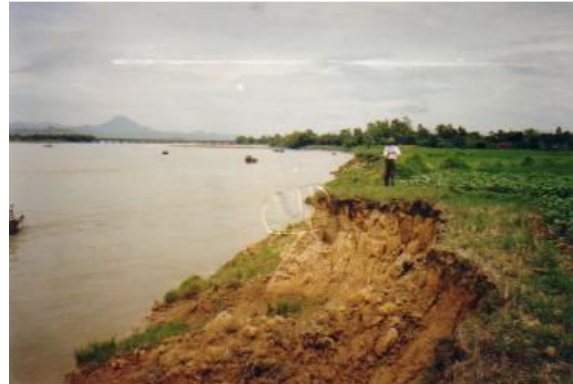
Figure 2 Bank erosion along Vu Gia river, at Dai Cuong Commune.

The problem of bank erosion along the Thu Bon river system was surveyed and studied at several sections, of which of special interest was the section from Tam Hoa commune on the Vu Gia river to Giao Thuy junction, where the Vu Gia conflues with the Thu Bon river (Fig.2). This has been in the recent years one of the most active sections in terms of bank erosion. The Vu Gia river

after meandering at Tam Hoa changes its course perpendicularly from NE to SE, directly attacking the My Hiep 1 village, Dai Cuong commune. Its first attempt to straighten its course appeared in 1997 becoming more and more obvious in subsequent years. Meanwhile, a little bit downstream the local dyke department undertook rigorous protection along the Quang Hue river, which used to

connect the two Vu Gia and Thu Bon rivers. Unfortunately, this protection also reduced the flow from Vu Gia to Thu Bon rivers during the flood season, forcing the first to find a new course i.e. to straighten. By July 2000, the Vu Gia river completed its straightening at My Hiep village (Dai Cuong Commune), forming a more than 1 km long new Quang Hue river, connecting with the old Quang Hue river at My Hiep 3 village, causing severe erosion along its two banks and discharged more than half of its volume onto the Thu Bon river. The disaster severely affected not only the local people who lost during 1997-2001 more than 300ha of arable land while more than 300 families themselves had to resettle. Moreover, Da Nang City therefore suffered from severe fresh water shortage and had to use blackish water, 7-11 times containing as high salt content as allowable. Inundation and erosion meanwhile accelerated downstream of the Thu Bon river from Giao Thuy junction to Dai rivermouth, severely threatening the Hoi An World Heritage.

On a river section 9km in length from Tam Hoa village to Giao Thuy junction, more than 5.2km was eroded ($K_e = 57.7\%$), erosion rate reached 20÷30m/year, the situation was assessed as severe.

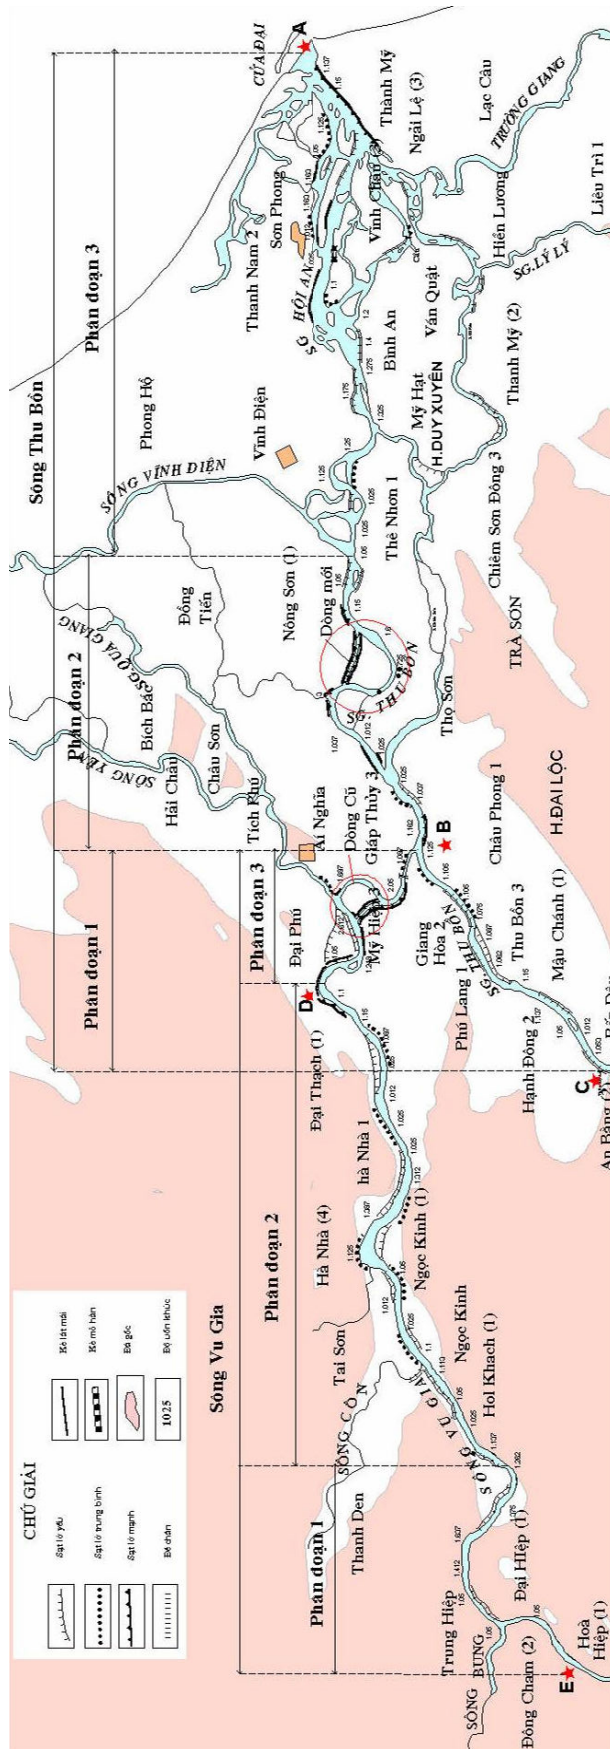
Figure 3 The erosion situation along VuGia and ThuBon rivers, QuangNam Provice
