# Pattern and determinant agents of the debris and mud flash flood in Lay Nua Commune area, the Former Muong Lay District, Dien Bien Province

**Abstract.** This paper discusses debris and mud flash flood, which is a widespread phenomenon with different levels of damaging effects and repetition in the mountainous areas of Vietnam. There are some sites where the flash flood with severe debris components has recurred many times and it has always caused heavy loss of human and materials, such as Lay Nua Commune, the Former Muong Lay District, Dien Bien Province. During the 1990s, this kind of severe hazard is recorded to occur every two years in the town of Former Muong Lay District. This leads to the government's decision to relocate the town to another place. Some characteristics of physiographical conditions such as climate, relief, lithologic and tectonic features, which are considered relevant to debris and mudflows activities, are analyzed, and then come to the conclusions on determinant agents of debris and mud flash flood in this area.

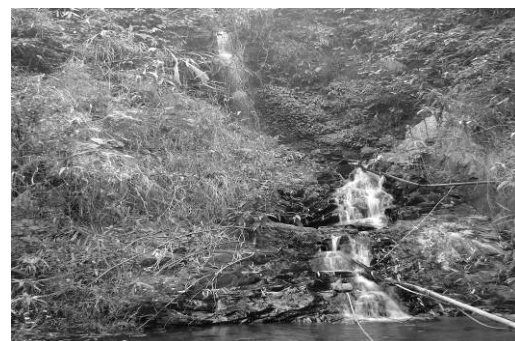
Fig. 7. A waterfall of 15 m high in Huoi Pien Stream.

- In addition to the common influence of the Lai Chau - Dien Bien left-lateral fault, the east side slope of the Nam Lay valley has been dismembered by several secondary longitudinal fissures forming 4 - 5 parallel steps (Fig. 1). As proofs of these longitudinal fissures we can see frequently within the four present here tributary streams (streams Huoi Lo, Huoi Pien, Huoi Moi, Huoi Phan) small falls and cataracts somewhere of more than 10 m in height corresponding to the hard bedrock exposures (mainly schists, basalt agglomerate and limestone) (Fig. 7).

one can see clearly the vestiges of the same "barrage" (Fig. 4, 7, and 9) in form of destroyed temporary dams or the huge rock blocks and boulders which are lying now across the stream valley, as well as a number of landslides on the slopes. Over a short period, the temporary dams will be breached and forming the debris and mud flash flood. The flowage of the mixture can be named as "breach debris and mud flash flood".

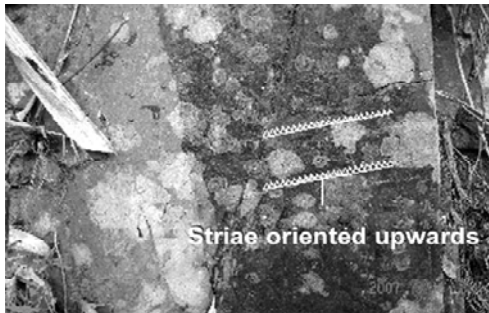
Fig. 8. Tectonic stria showing a normal fault, Huoi Pien Stream.
