LAND SUBSIDENCE HAZARD DUE TO KARST IN VIETNAM AND MITIGATION MEASURES

DUONG THI TOAN¹, VU CAO MINH^{1,2}, DOAN VAN TUYEN²

ABSTRACT: In Vietnam karst caused land subsidence is serious problem, especially when it is occurring in limestone rocks covered by upper soil layer with the thickness of 30-40m. The deformation of the ground is dominantly resulted in collapsed depression or hole with circle shape on the ground surface. The diameters vary from 2 to 5m, reaching upto 5-10m in some places. Although funnel type of the subsidence is less common, it has widely impacting diameter. The main factors causing this type of hazard are the water table drawdown due to drought and groundwater overextraction, mining exploitation.... This paper studies the land subsidence hazard related to karst topography in some areas in Vietnam and suggests the preventive measures for reducing this type of disaster. The preventive solutions are relocating population from dangerous areas, strictly control the exploitation regulations and procedures, maintaining rational water use in the regions of karst topography. The question how to improve kart surveying is also discussed.

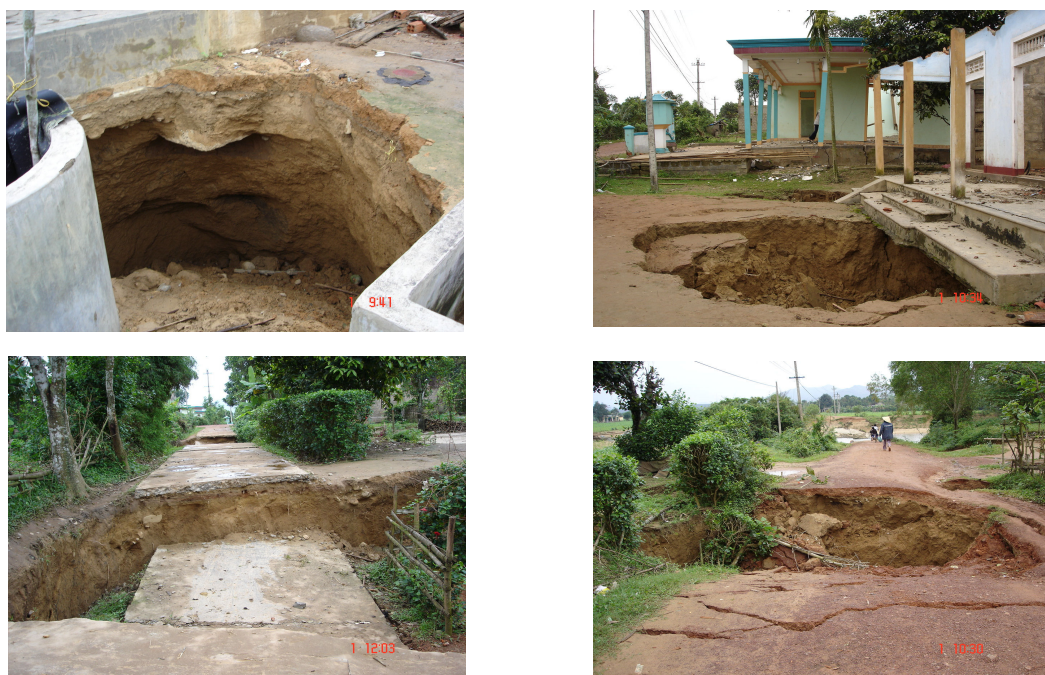
Figure 1 Sink holes Land subsidence in Tan Hiep commune, Cam Lo district, Quang Tri province (February, 2006).

was detected at 21clook on 18/02/2006 and had appeared scattered in the following days. Up to 03/03/2006, Tan Hiep village has identified 52 landslides, large and small holes, distributed in a strip with a width of 150-200 m, length 300 m. The holes are mostly round, offer size, maximum diameter 25 m, 0.2 m minimum, and average 4-5 m. The sink holes have the shape in typical funnel expanding in the bottom expand and link together to form a set of karst funnel causing the groundwater flow when

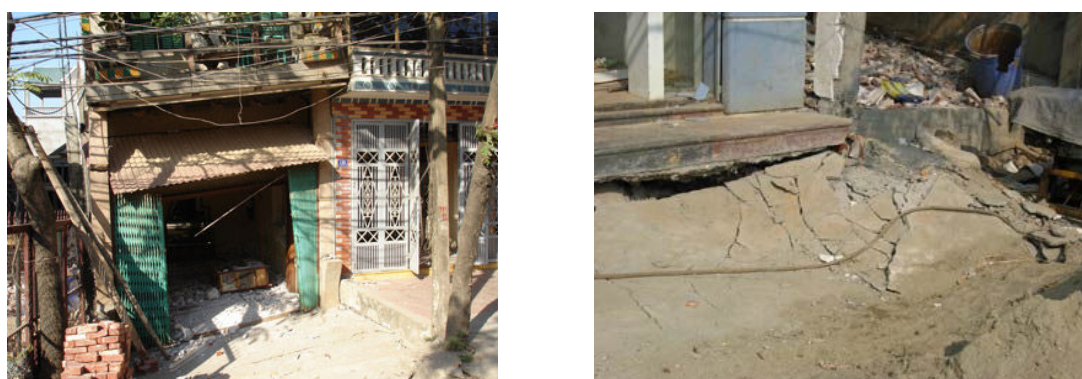
Figure 2 Land subsidence in Quoc Oai district, Ha Noi (November 2008)

From 2006 to now, in the former province of Ha Tay (now belongs to Hanoi), there were three ground craking incidents breaking houses (Fig. 2). All these regional

problems occurred when people digging wells to extract ground water. November 2008, at Quoc Oai Town, has serious incidents stem from domestic wells for household. Subsidence wide radius to 70 - 80m, the deepest collapse was measured about 1.4 m and tended to spread to the

provincial highway No.419 where was cracked about 20m long, wide cracks from 4 - 5cm.

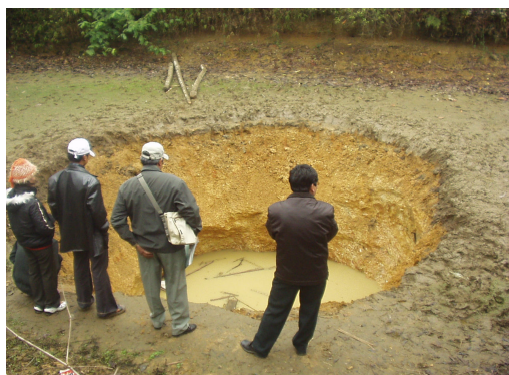
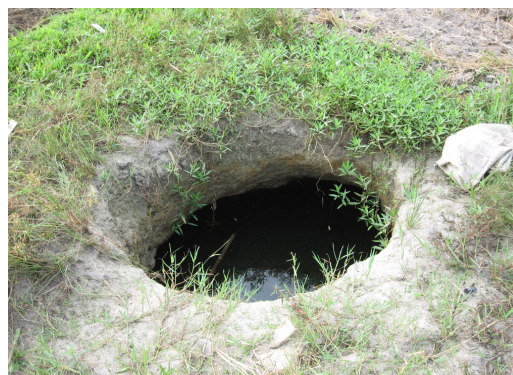
Land subsidence hole in Tan Thanh

Land subsidence hole in An Tuong

Figure 3 Land subsidence in Tuyen Quang

This area frequent occurrence of karst subsidence hazard, particularly in the year 2004 - 2005 many sinkholes have appeared in the Tan Thanh village, Tan Quang township, Ham Yen district, and the village of La-Y, An Tuong, Luong Son in Yen Son district. (Figure 3). Since 2009, land subsidence occurred seriously due karsts at highway No.2, at Tuyen Quang township (Tuyen Quang province), while the widest hole has the diameter of 3-4m and the depth of about 5m, causing many traffic accidents on this road. Based on the results of geo-physical, geotechnical investigation, the reason caused surface land subsidence is the collapsing of karsts hole in the underground and these hole had been filled by the soft soil as mud and sand cause the mud lenses with the thickness of 5-7m.

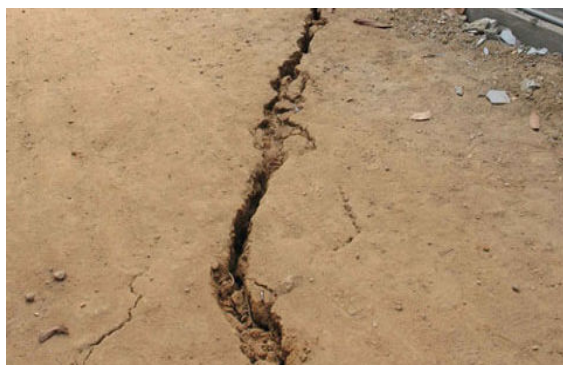
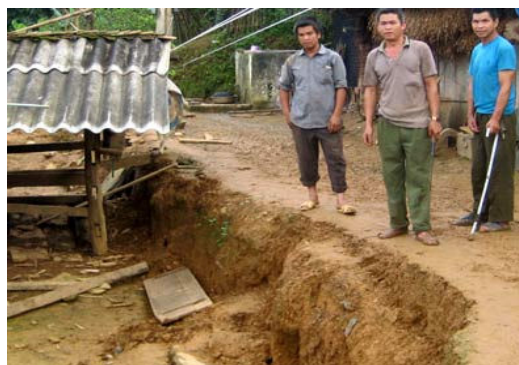
Figure 4 Ground craks and land subsidence at Trai Cau, Dong Hy, Thai Nguyen province

In 5 years recently, the land subsidence appeared and extended in the large area in the Trai Cau town, Dong Hy district (Figure 4). To July 2010, it was found nearly 10 sinkholes with sizes up to 5-7m and many cracks in the ground surface. More than 100 households are affected, while nearly 10 houses were damaged.
